## **SELLER'S DISCLOSURE NOTICE**

**SUPPORTING AND ADDITIONAL MATERIAL FOR PROPERTY: 6541 ORIOLE Dr. Dallas, TX 75209**

## STRUCTURAL INVESTIGATION & REPAIRS PHASE 1

## Structural Review of Construction

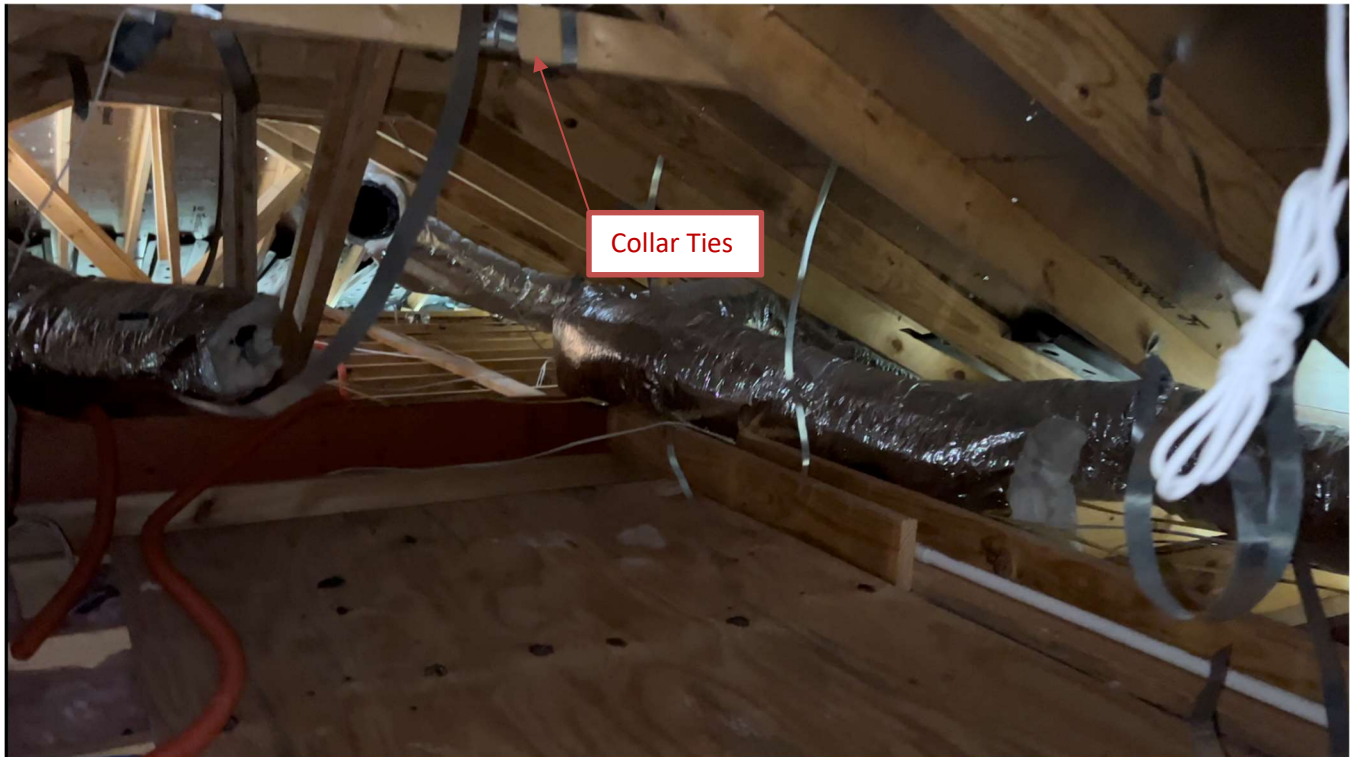
Photo 1

These collar ties can be seen in **[Photo 1]**. However, not all rafters had collar ties and thus collar ties are to be added to the framing in the areas they were omitted as seen in **[Photo 2]**. See [Detail 1](#) for the recommended repair detail.

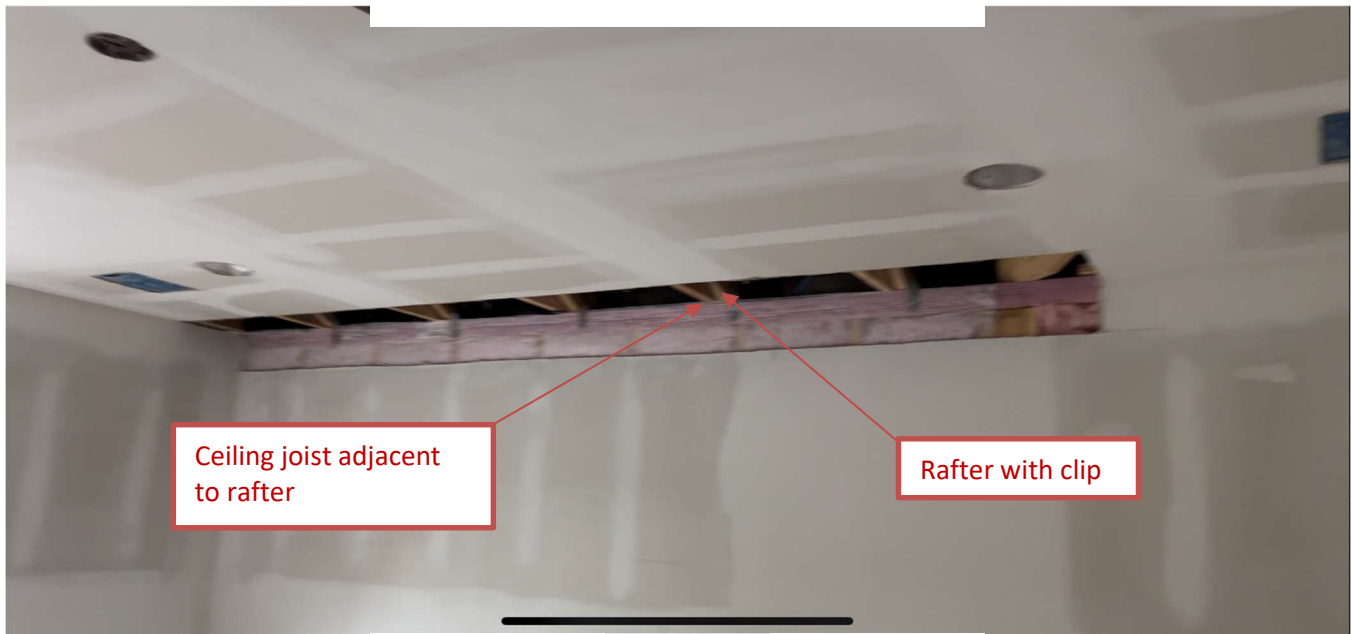
Photo 3

To keep the bottom of the rafters from uplifting off the wall, a metal clip is used attaching the rafter to the wall as can be seen in **[Photo 3]**. These clips were added after-the-fact as noted by the removal of the sheetrock and the attachment of the clips over the membrane instead of under it. However, it is not known whether these clips were added everywhere. For example, behind the shower wall as seen in **[Photo 4]**. These clips need to be in place prior to finishing construction.

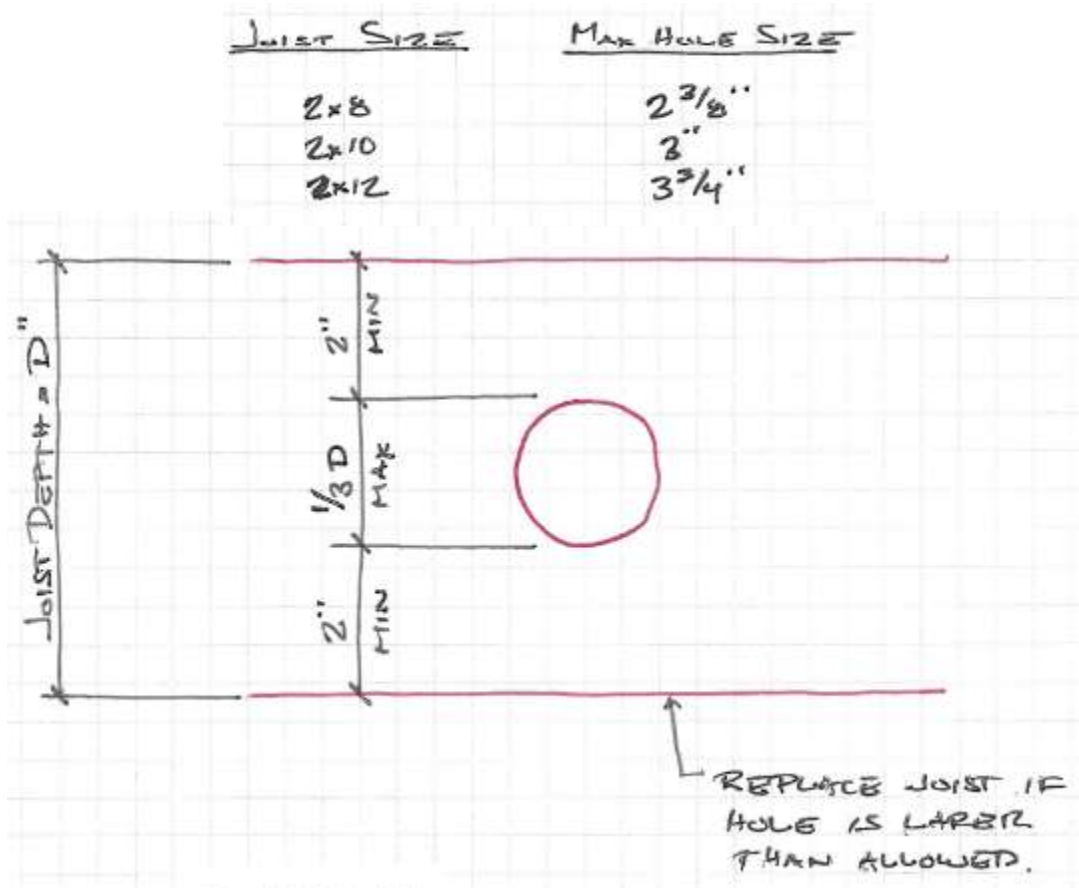
Detail 6

The second-floor framing supports the gravity load for dead and live loads on the second floor as well as supports roof load in some locations. For the most part, the floor joists are adequately sized. However, some have been damaged with bored holes too large per code standards. See [Detail 6](#) for hole allowances and replace all joists that do not comply. This

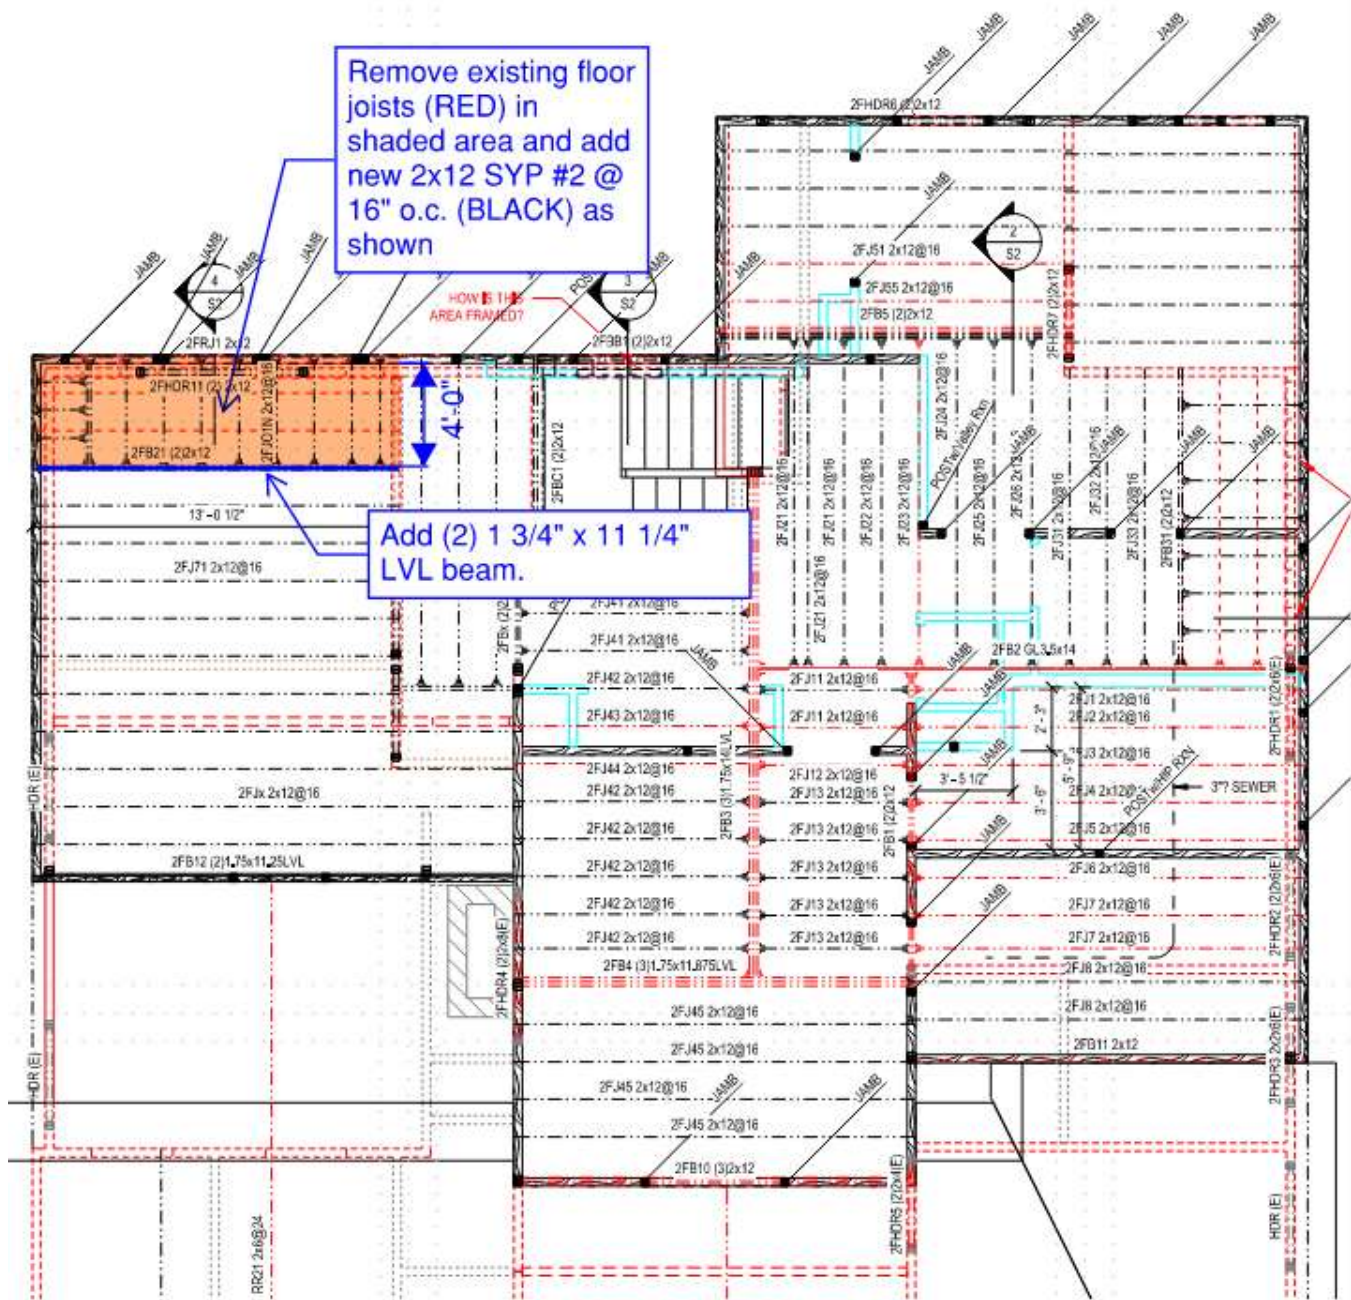
**Detail 7**

There are some floor joists that cantilever over the first-floor wall to provide a flush and smooth transition between the second-floor siding and first floor brick façade. To achieve this properly, framing must be turned perpendicular to one another, like the ceiling joist framing when the exterior wall turns ninety degrees. The location of this framing and their remedies can be found in the attached [Detail 7](#) and [Detail 8](#).

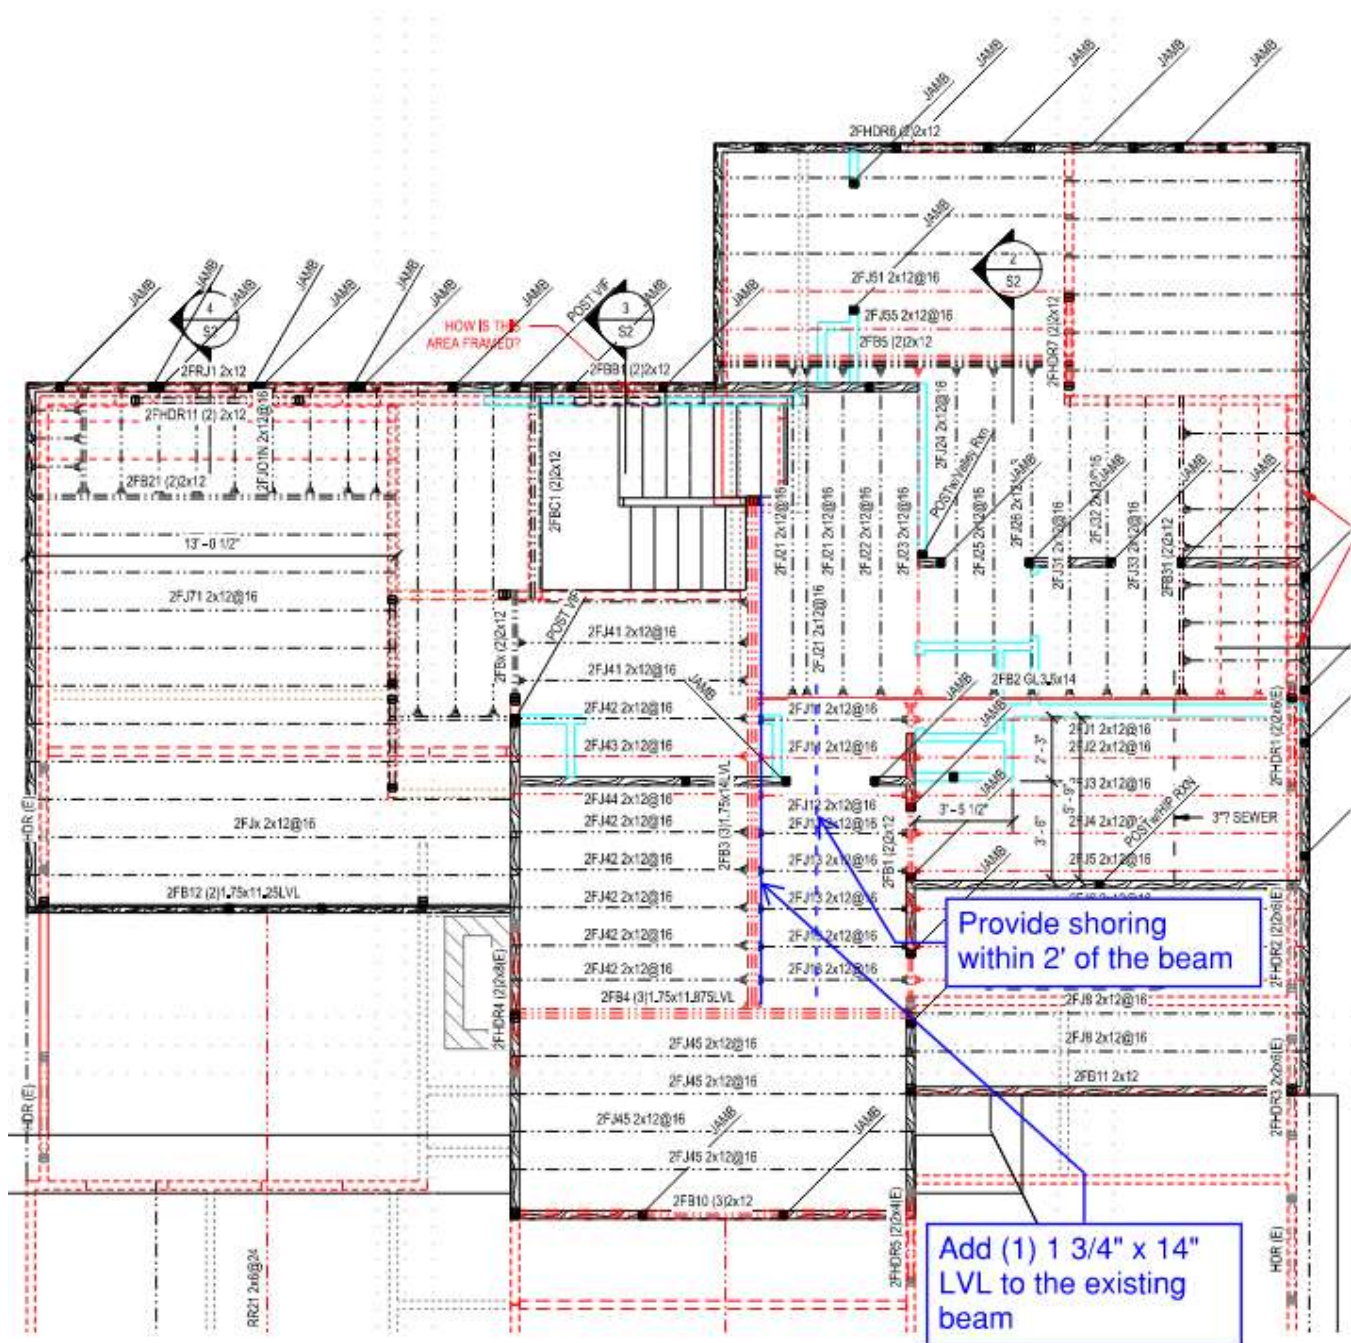
**Detail 9**

The large open area above the kitchen and living room could not be achieved without the use of large beams supporting the floor joists. I have reviewed the engineering for each of these beams and have found most of them to be insufficient. There are repairs that can be made to each of these beams to provide the adequate framing necessary to support the second floor. The locations and repairs needed can be foundation in [Details 9 through 14](#).

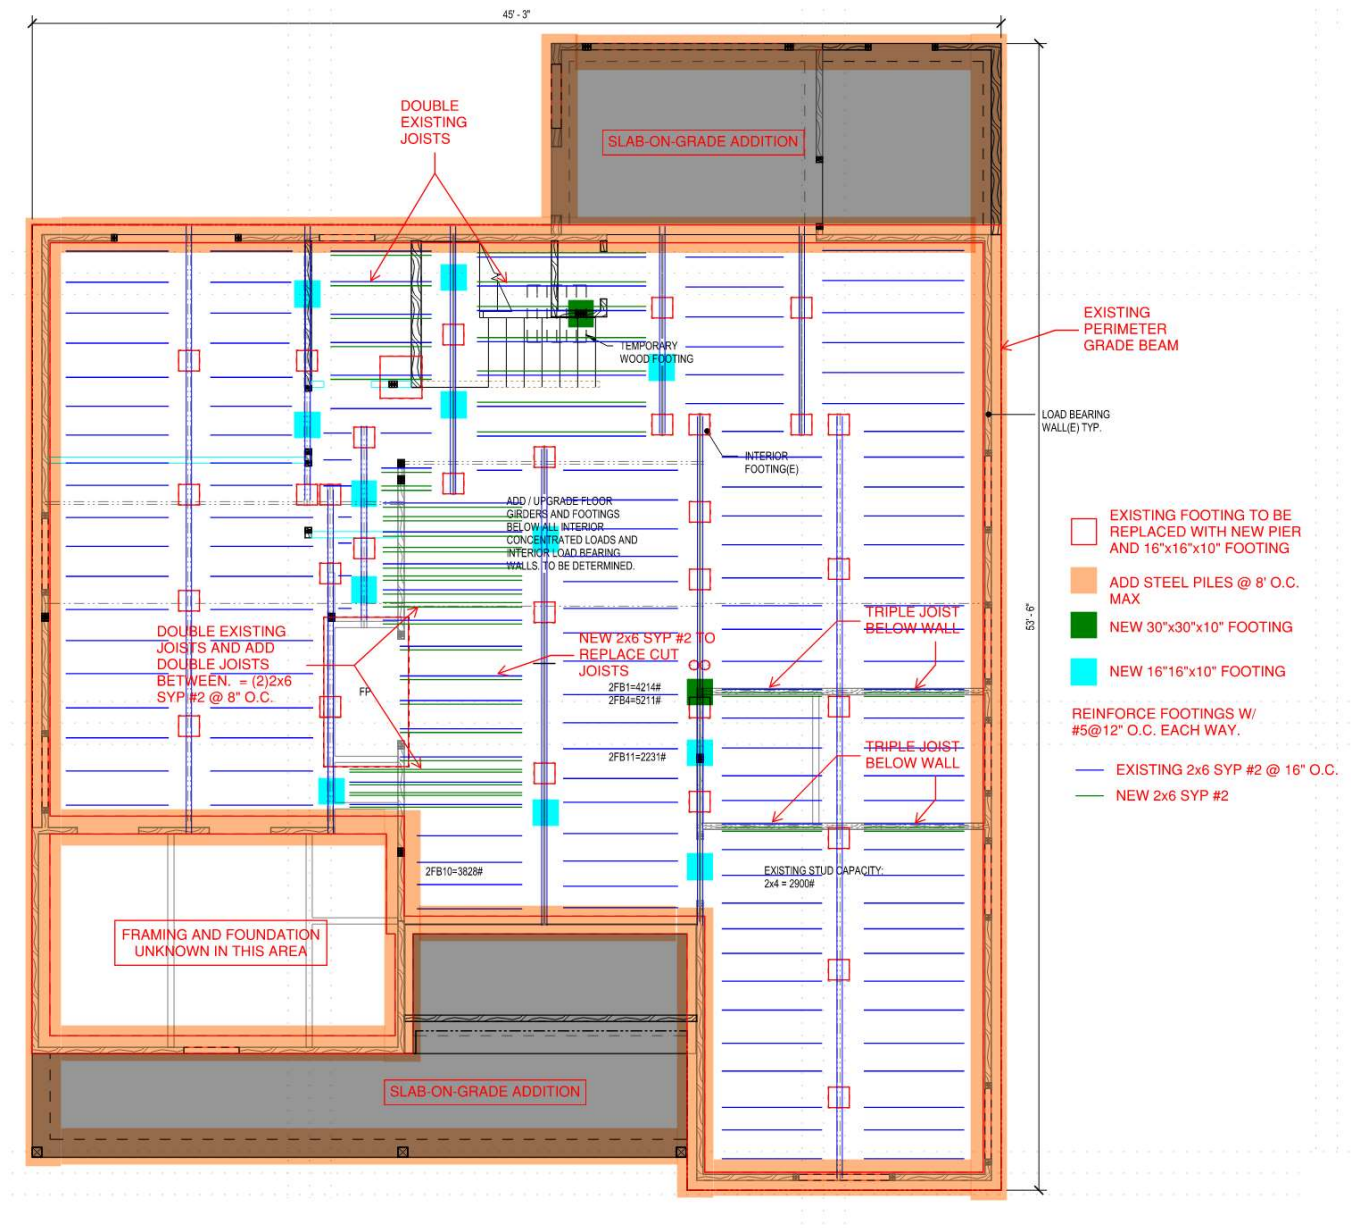
**Detail 16**

I have followed the load path of the new framing down through the foundation and have developed a potential plan for supporting the new load. The attached [Detail 16](#) shows existing pier locations provided by the homeowner based on a survey personally done by the homeowner. I have also shown where new piers need to be constructed to support the new framing conditions as well as where existing joist framing needs reinforced to also support new bearing walls and loading conditions. The foundation system currently has three foundation types, thus providing differential movements between the different types of foundation. In an effort to reduce the foundation types and get the foundation to act more uniformly, I recommend adding piers around the perimeter of the original foundation as well as around the perimeters of the new slab-on-grade foundations. I also recommend that the existing interior piers be replaced to match the interior piers required for the new loads from the second floor. This will ensure a more uniform foundation without the differential movements, which is how the foundation performed for the homeowner prior to the addition of the second floor. [Detail 17](#) shows the new pier and footing construction to be used. This pier detail is based on the allowable bearing load of 1,500 psf per 2015 IRC Table R401.4.1 for CL, ML, MH and CH soils, which are abundant in the Dallas area. The new piers around the old and new foundation perimeters should be steel piles down to refusal.

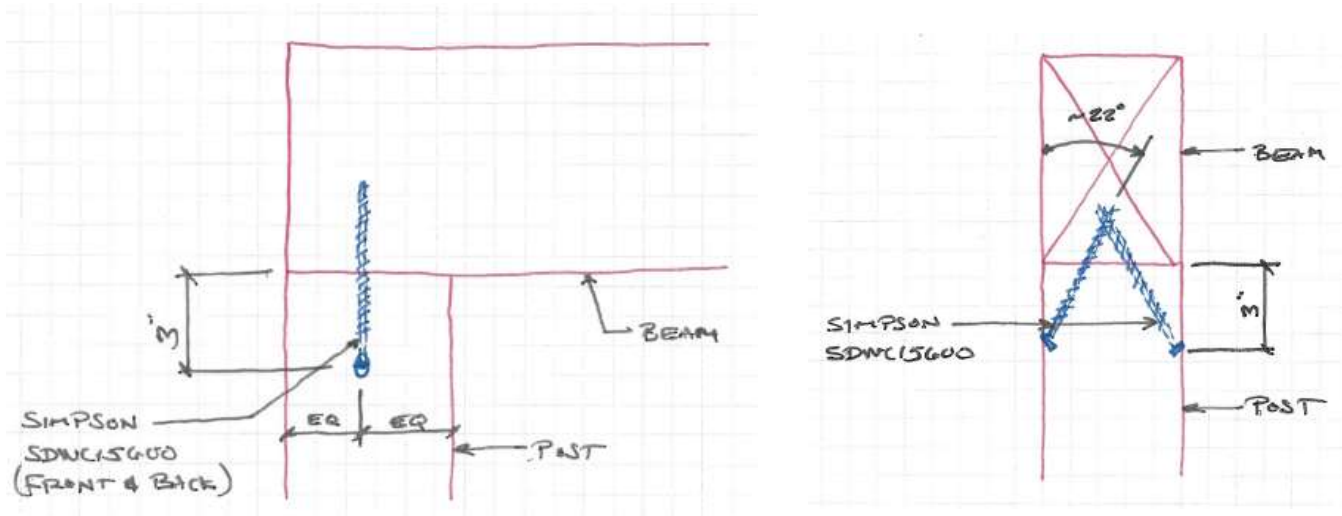
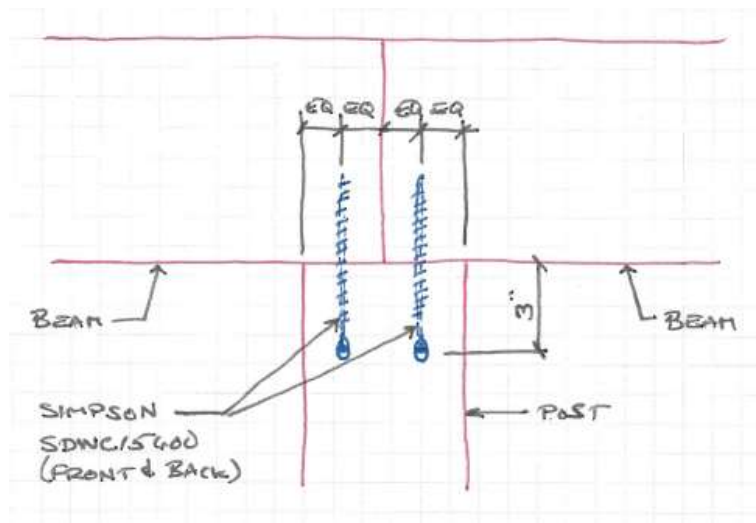
Detail 19

The new front patio framing also has a couple of issues. One, the posts do not have any anchorage to the foundation. I would recommend using the Simpson retrofit post base, RPBZ, to provide the appropriate anchorage at each of the posts. The corner posts will require only one (1) RPBZ and the interior posts will require two (2) RPBZ. The second issue is the roof over the patio visually appears to be sloping downward from right to left. This slope was not present when I visited the residence in June last year and has been slowly increasing since then. This potentially points to an issue with the foundation, which will be discussed later in this report. A third patio framing issue concerns a lack of any connection between the front patio beams and the posts. Should the beams be lifted to level, a Simpson post cap, PCZ, can be installed between the top of the post and the bottom of the beam at that time. Use an EPCZ for the end posts and a PCZ for the interior posts. If the beams are not lifted, then Simpson SDWC15600 screws can be used to anchor the beams to the post per [Detail 19](#).
