## **SELLER'S DISCLOSURE NOTICE**

**SUPPORTING AND ADDITIONAL MATERIAL FOR PROPERTY: 6541 ORIOLE Dr. Dallas, TX 75209**

## STRUCTURAL INVESTIGATION & REPAIRS PHASE 1

## Structural Review of Construction

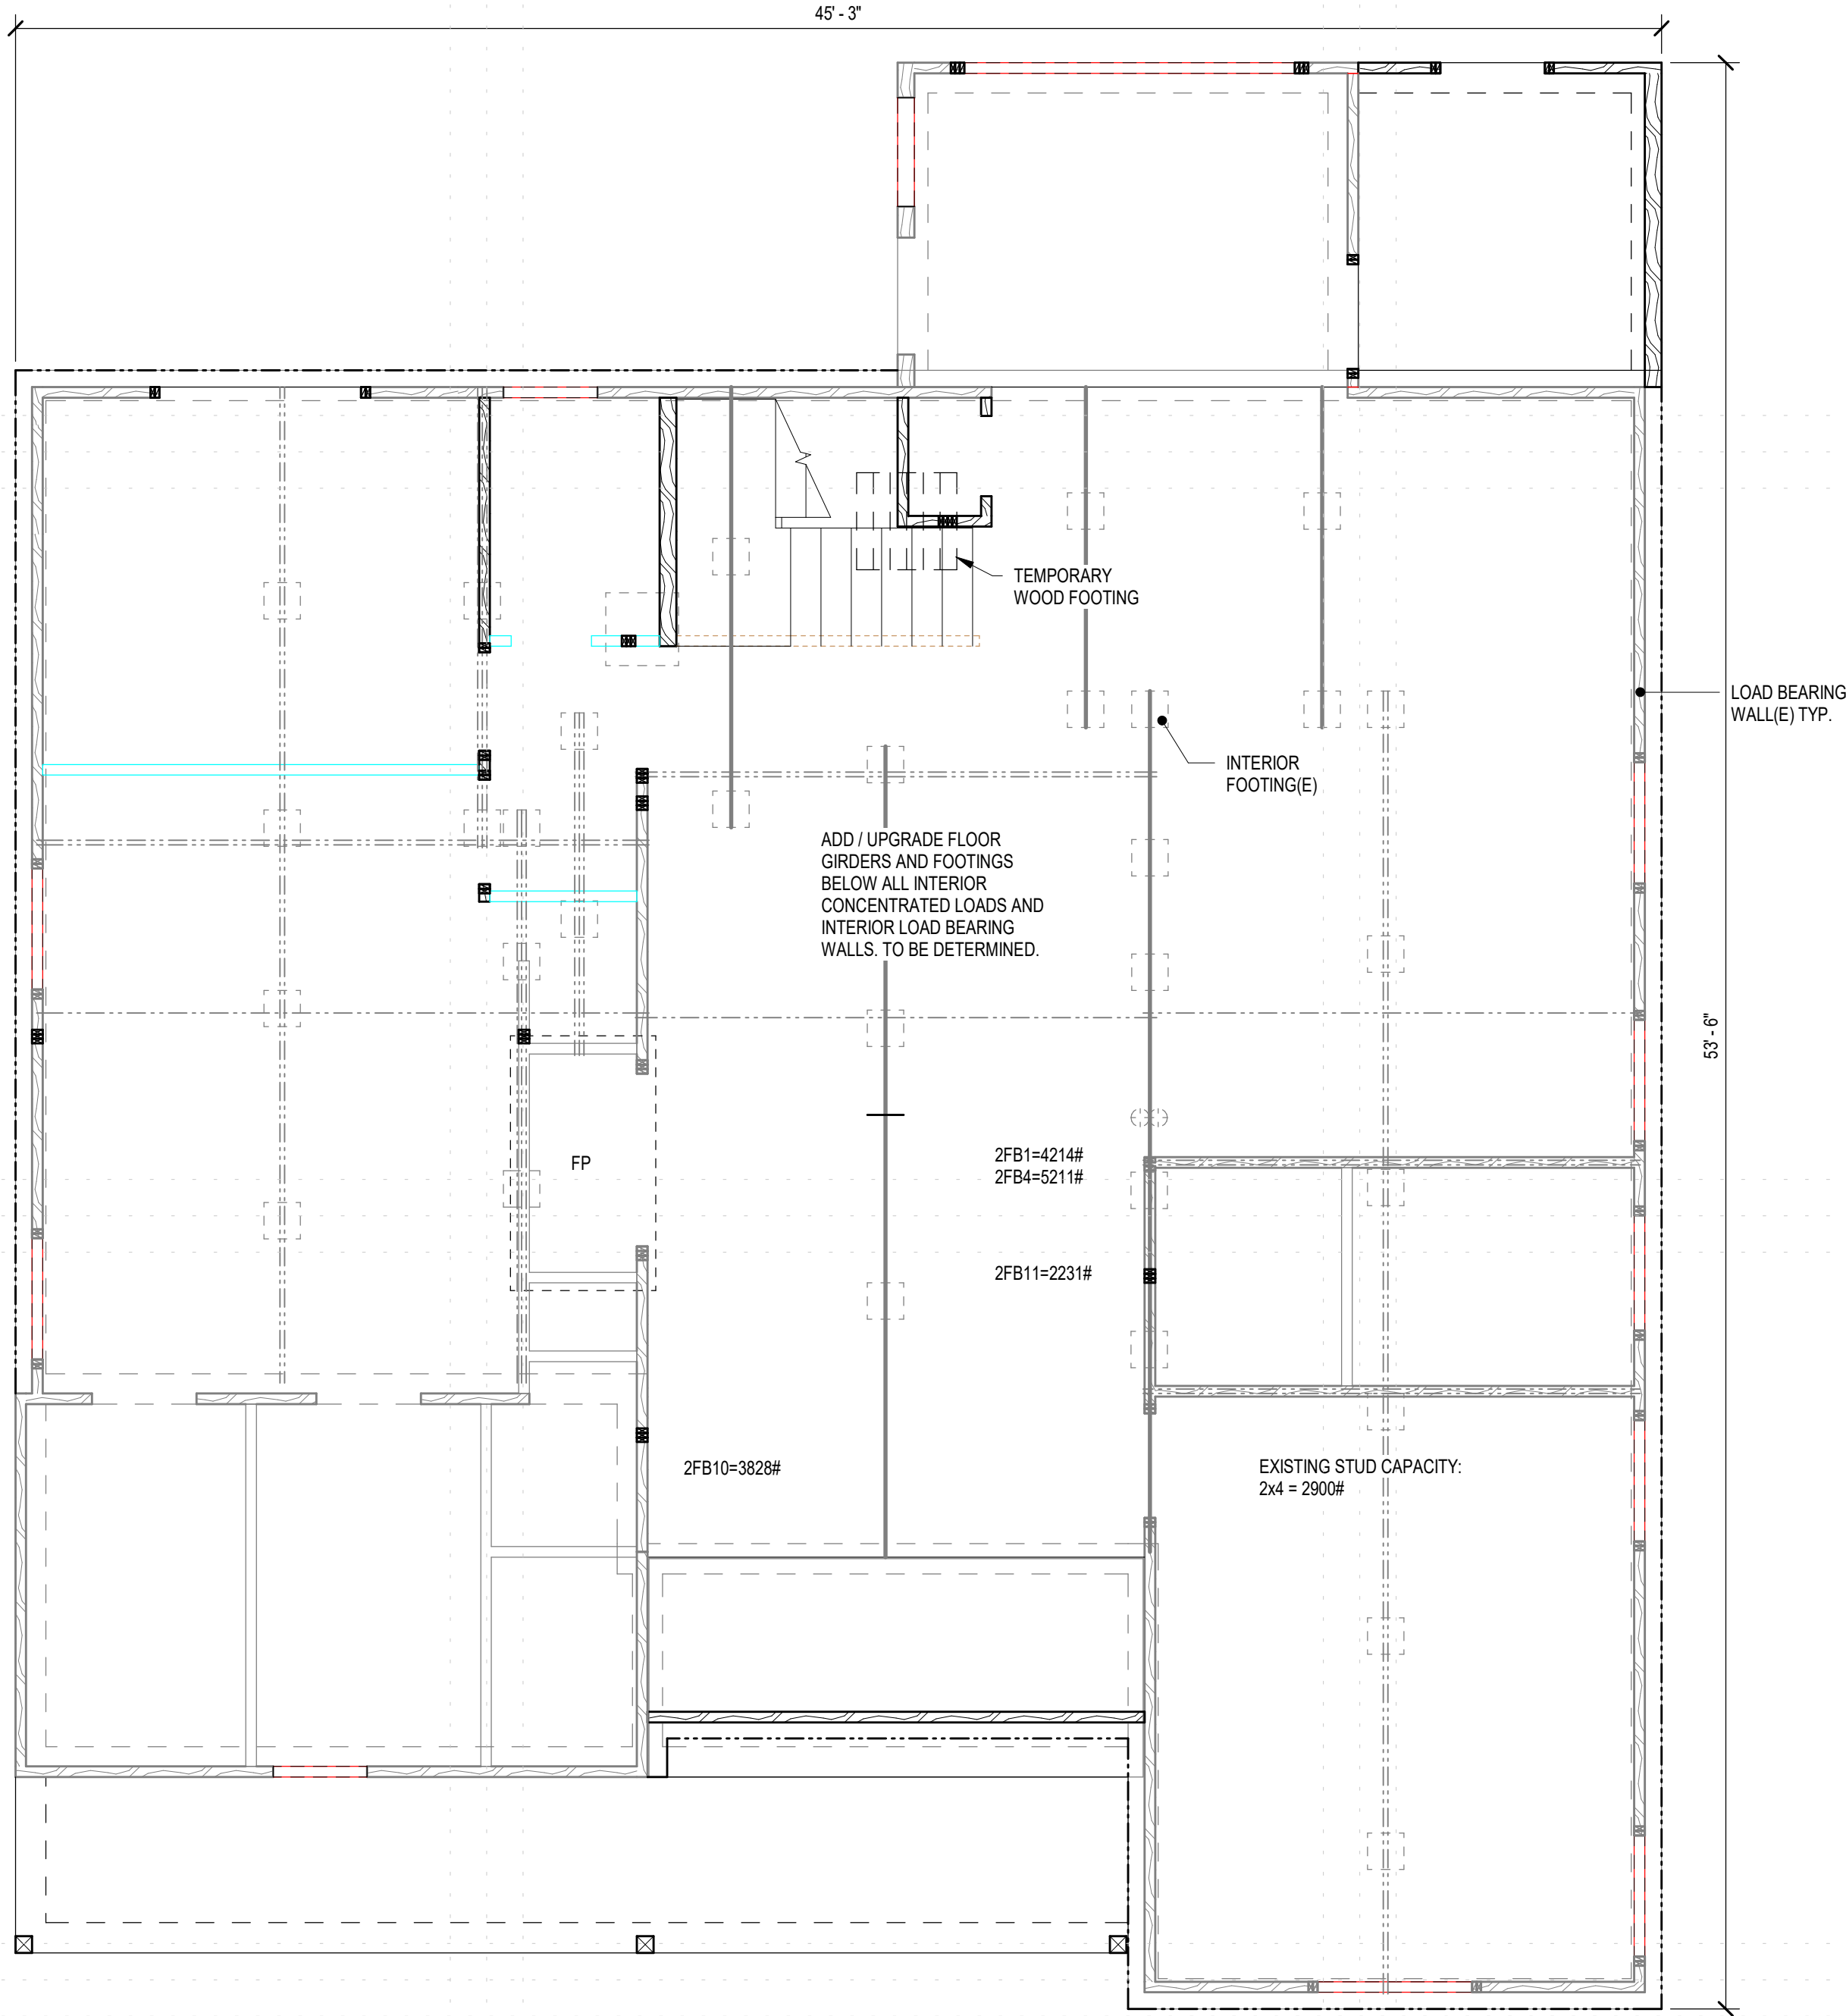
① Level 1  
1/4" = 1'-0"

19. Some of the existing 1<sup>st</sup> Floor framing is overloaded. *The first floor framing replacement members and added foundations are being evaluated.*

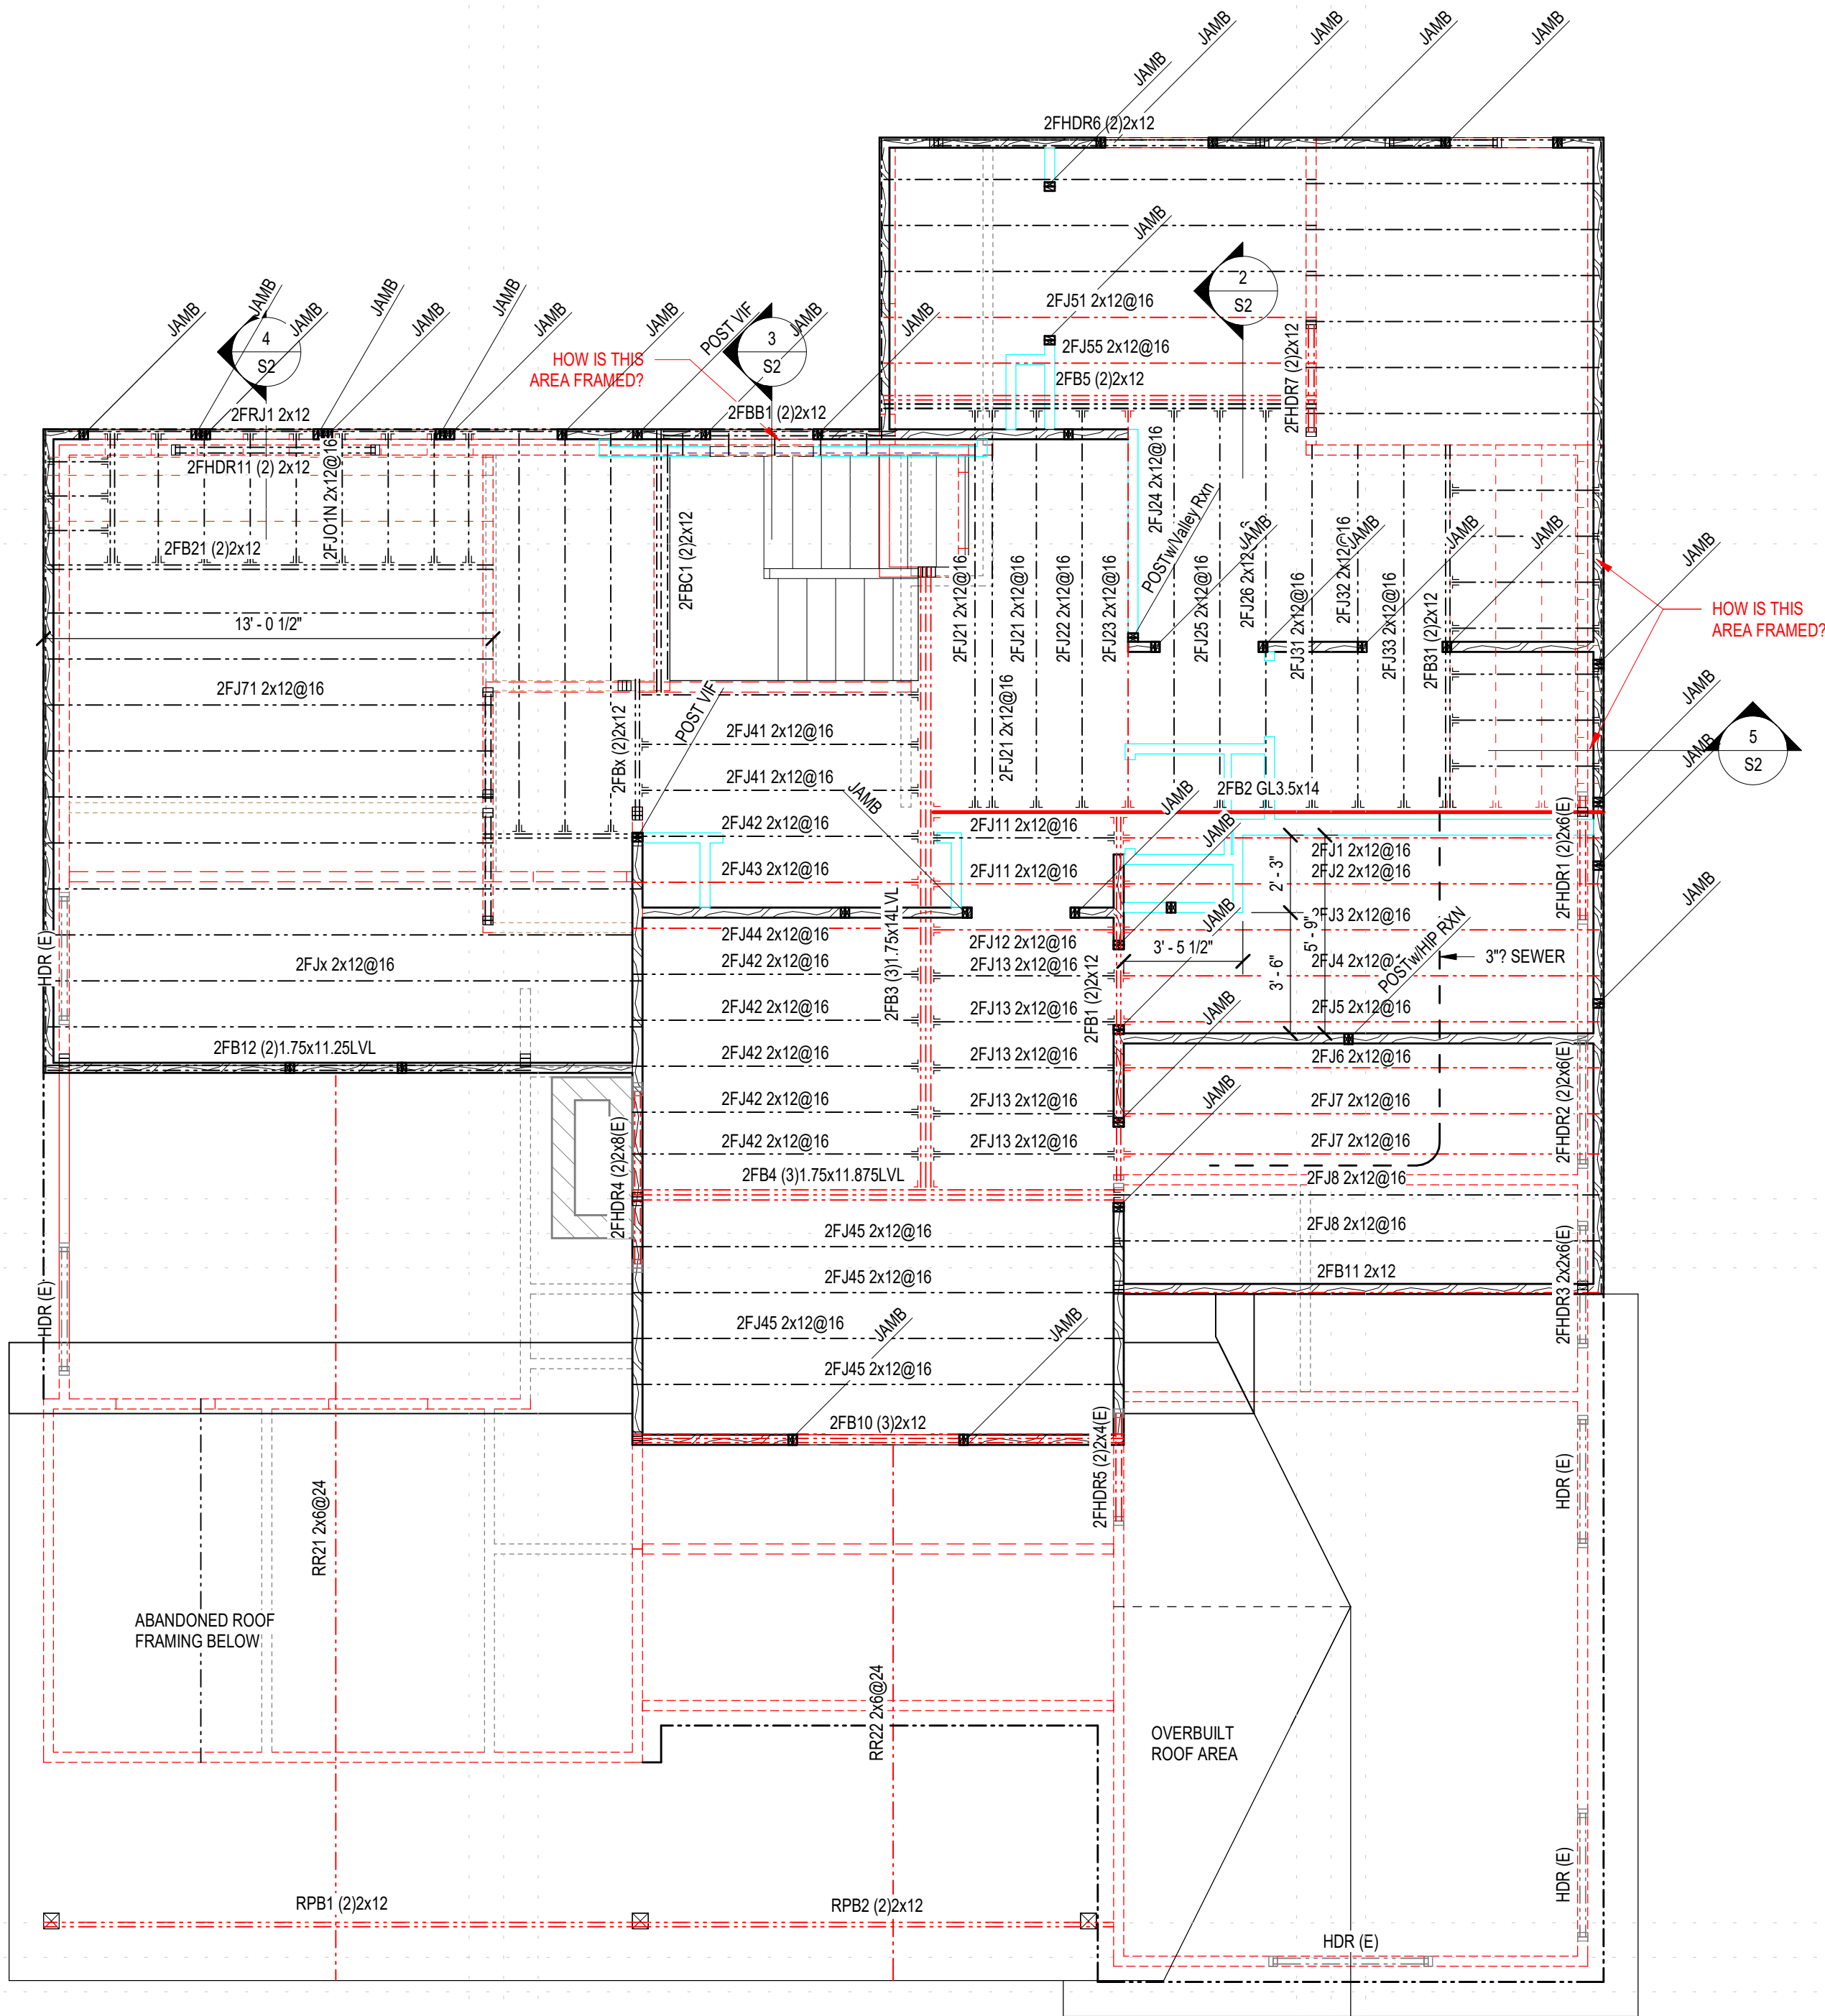
1 Level 2  
1/4" = 1'-0"

15. Some of the new ceiling framing is overloaded. *See structural drawings for overloaded members and the replacement member sizes.*
16. Some of the new and existing 2<sup>nd</sup> Floor framing is overloaded. *See structural drawings for overloaded members and the replacement member sizes.*

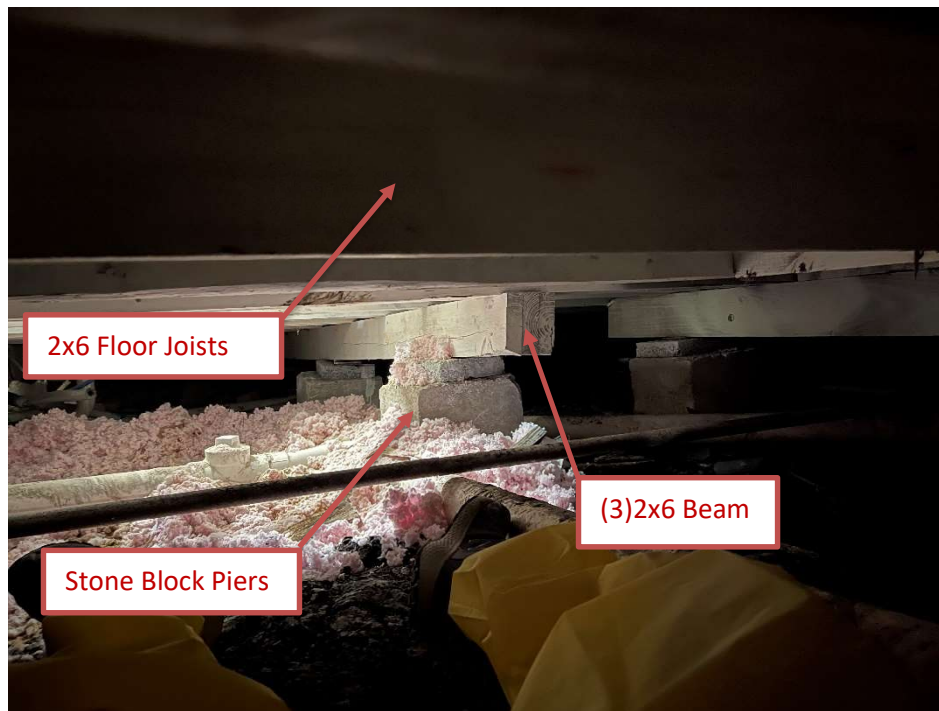
Photo 9

With the roof and floor loads now supported down to the first-floor framing, those loads need to transfer into the ground. The existing first floor framing appears to be the original framing: 2x6 joists spaced at sixteen inches on center resting on triple 2x6 beams spanning between stone block piers **[Photo 9]**. It is unknown if those stone blocks bear directly on grade or are supported by a wood or concrete pier or a concrete spread footing below them. The original perimeter footing is poured concrete. There is one photo **[Photo 10]** taken by the homeowner which may suggest the perimeter grade beam is supported on a pier, although this cannot be confirmed without digging under the perimeter footing in several locations. There are also cylindrical concrete piers supported on concrete pads **[Photo 11]**, suggesting that were likely added after the original construction. A new pad consisting of 6x6 timbers laid horizontally was added under the new beam at the stairwell **[Photo 12]** to stop the floor deflection due to a lack of foundation support prior to constructing the new framing.
